The Uniform Building Inspection Report™ Condensed

Single Family Residence:
4568 W Morrison Drive, Chicago, IL.

Inspection Date:
1/6/2006, 9:00:00 AM

Inspection Company:
Platinum Home Inspections, Inc.
William A. Riga Sr., 050-0001923
,
Chicago , IL. 60632
(773) 972-2243

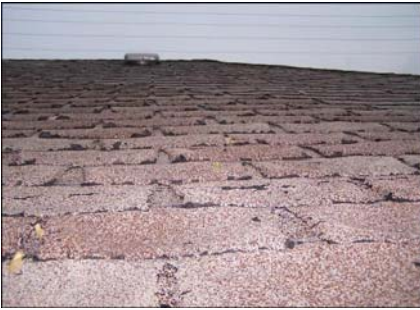
Photo: 1020.01 (1)

[P] [R] [R] 1020.01: The roof appears to be at the end of its useful life. Prepare to replace at this time. A second opinion is recommended.
The house roof is cracked and dried and aged prematurely. Should replace the roof at this time, by a licensed roofing contractor.
See series 1020.01 photo(s)

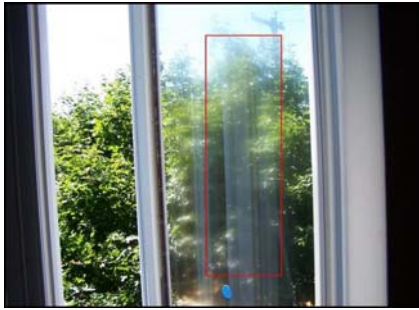
Photo: 1510.01 (1)

[P] 1510.01: Insulated window (I.G.) appears to have lost seal. The window has lost its seal and needs to be replaced. See the windows which has been marked by an X with a grease pencil. Correction or modification of this finding decreases the probability of excessive deterioration of the noted component(s) and is recommended.
See series 1510.01 photo(s)

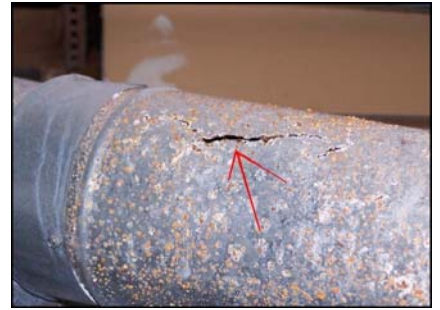
Photo: 2150.04 (1)

[H] [R] 2150.04: Heat system vent improper.
THIS is a high efficiency Condensate Furnace and as such the vent pipe should be P.V.C. pipe. installation of a metal vent will cause corrosion due to the corrosive exhaust gasses. Recommend that the pipe be replaced with P.V.C. pipe and be exhausted through the side of the house as the manufacture intended. It is recommended that a qualified licensed contractor review the finding and correct as needed.
See series 2150.04 photo(s)

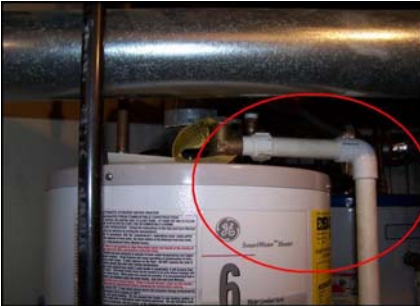
Photo: 4150.03 (1)

[H] [H] 4150.03: Water heater pressure / temperature relief valve discharge line improper type.

The Temperature Pressure Relief discharge line is currently a flex material. The discharge line should be a non threaded end rigid three quarter pipe only which extends six to twelve inches above finish floor level. Correction is advised.. It is recommended that a qualified licensed contractor review the finding and correct as needed.

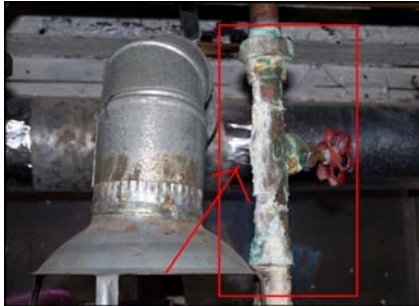
Photo: 4430 (1)

[E] [P] 4430: Water pipes or fittings corroded and/or leaking. The union on top of the water heater is corroded and leaking. Recommend replacement of the defective union and any further correction needed.

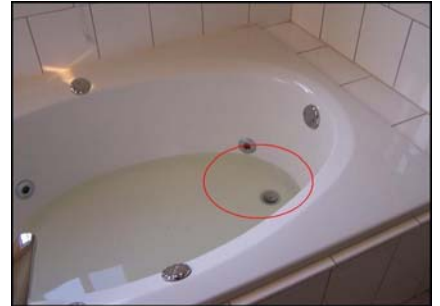
Photo: 4680 (1)

[E] 4680: Fixture drain slow or clogged. The drains are slow and will need to be routed or cleaned by a licensed plumber this condition exists on the second floor master bathroom. Repair, alteration, or replacement usually improves the efficiency of the component or system and is advised. See series 4680 photo(s)

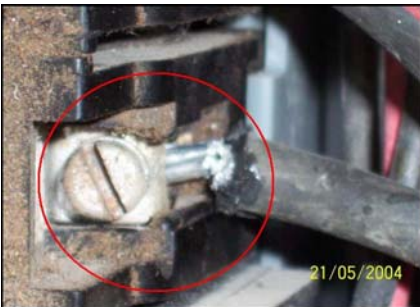
Photo: 5100.04 (1)

[E] [H] [R] 5100.04: Main panel faulty or otherwise amiss. The main entrance connector has been compromised. Conductors have been cut. Left in the present condition the component may continue to deteriorate or cause undue damage to other components. Corrections by a qualified licensed contractor are advised. See series 5100.04 photo(s)

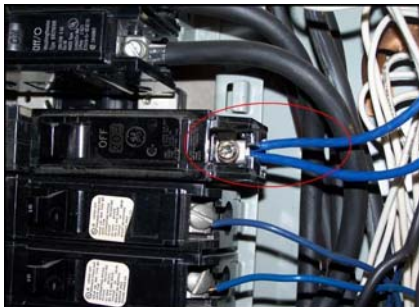
Photo: 5230 (1)

[R] [H] 5230:
Double wires on breaker or fuse.
Two circuit breakers are "double tapped", where 2 or more wires are clamped in a circuit breaker terminal that's designed for only 1 wire. This is a safety hazard since wires may loosen and cause arcing, sparking and fires. Recommend having a qualified, licensed electrician evaluate and repair. One possible solution is to install additional circuit breakers. It is recommended that a qualified licensed contractor review the finding and correct as needed. See series 5230 photo(s)

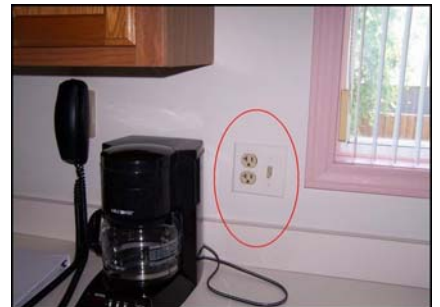
Photo: 8190.01 (1)

[U] [R] 8190.01: Receptacle outlet(s) intended for kitchen countertop use not GFCI type.
Kitchen Wall Receptacles The outlets at kitchen counter top are within 72 inches of a water source. Although Ground Fault Circuit Interrupters was not required when the house was built it is recommended that any outlet with 72 inches of a water source be replaced with a Ground Fault Circuit Interrupter for safety reasons. The replacement of these outlets would be considered an upgrade and is advised.
See series 8190.01 photo(s)

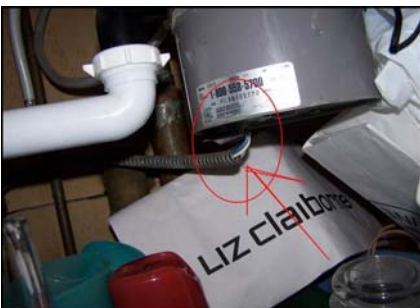
Photo: 8450.01 (1)

[H] [R] 8450.01: Disposal electric supply wire not secure to unit. The electrical supply to the disposal should not ave a exposed junction, or be able to be damaged by contact. Recommend that the electrical supply wire be attached with a permanent electrical connector. It is recommended that a qualified licensed contractor review the finding and correct as needed.
See series 8450.01 photo(s)

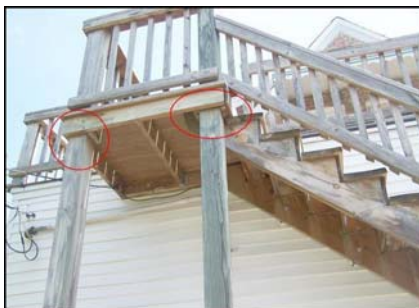
Photo: 9220.01 (1)

[H] [R] 9220.01: Unsafe framing member potential. The main supporting 6x6 are nailed to the supporting facia boards. It is recommend that all supporting members be through bolted with either hot dipped galvanized or stainless steel bolts.
It is recommended that a qualified licensed contractor review the finding and correct as needed.
See series 9220.01 photo(s)
